## Visibility of the Proposed Project Area from the Columbia River Key Viewing Area

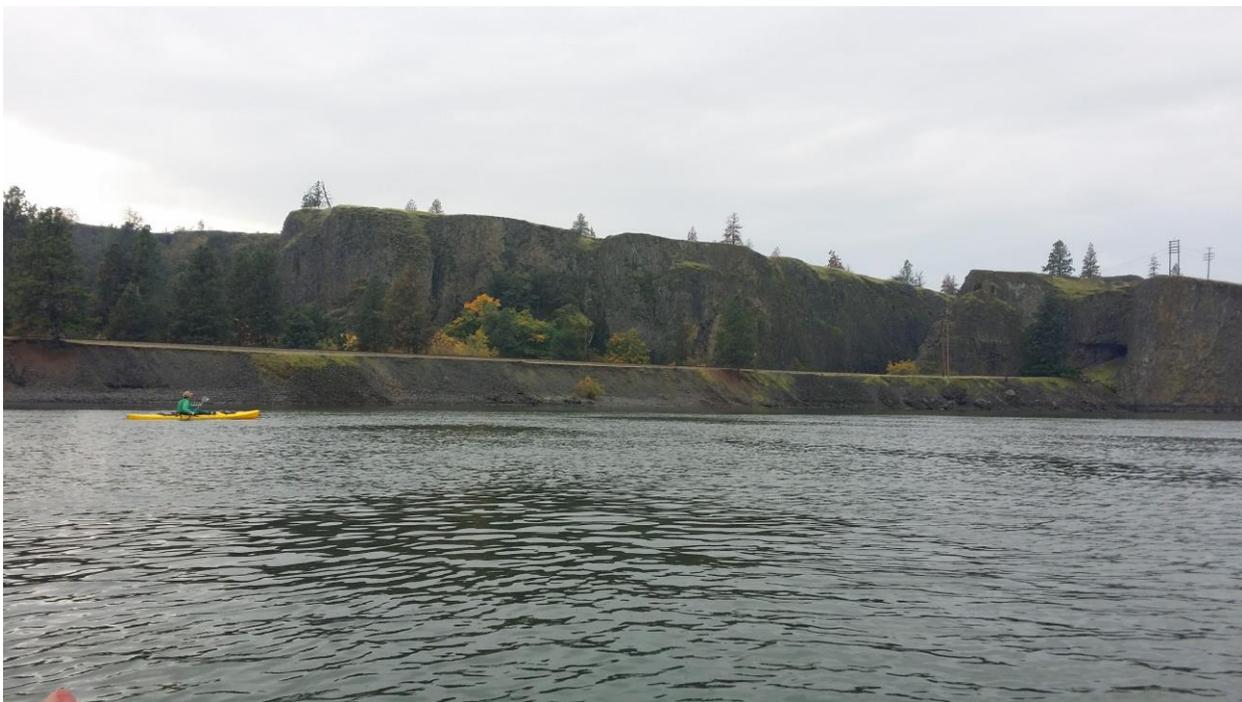
This photograph shows the existing cut through the rock mesa at approximately milepost 71.4 within the project area. The expansion of this rock cut as proposed by the applicant will be clearly visible to all river uses, will not meet the not visually evident standard, and will greatly contribute to the cumulative adverse effects of the project.

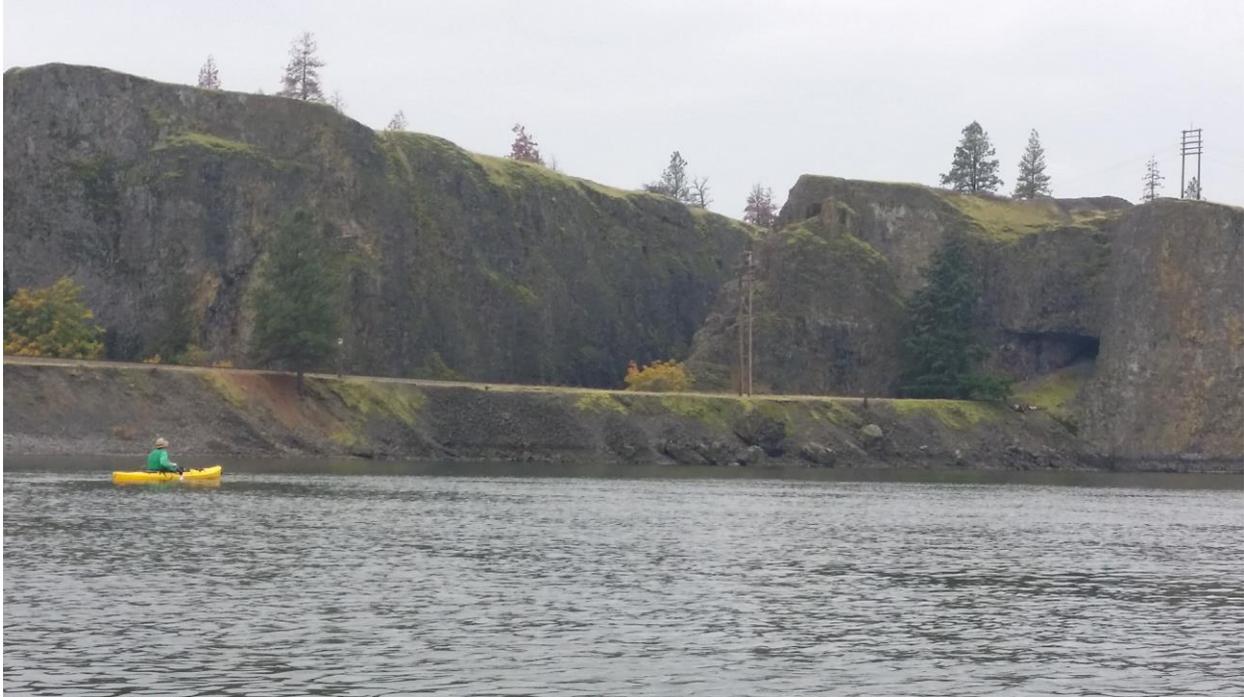
This photograph depicts a closer view of the rock cut that the applicant proposes to expand. The applicant and the Planning Commission do not propose any screening vegetation to attempt to meet scenic area standards.

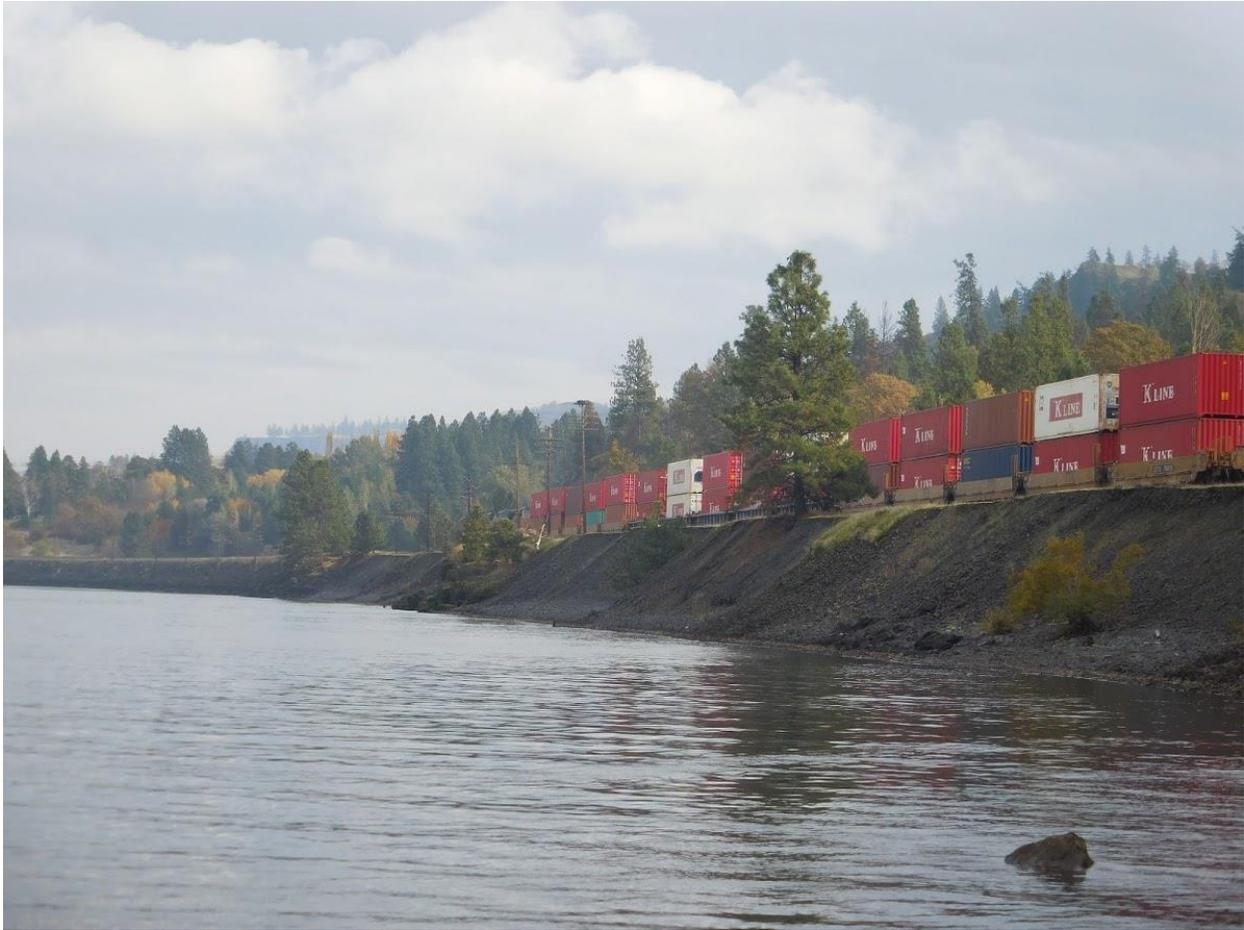
This is a view of a train traversing the project area. The train visually dominates the area. Even an increase in traffic of 5–7 trains per day or an increase in the length of trains would have large cumulative adverse impacts on the scenic resources of the NSA.

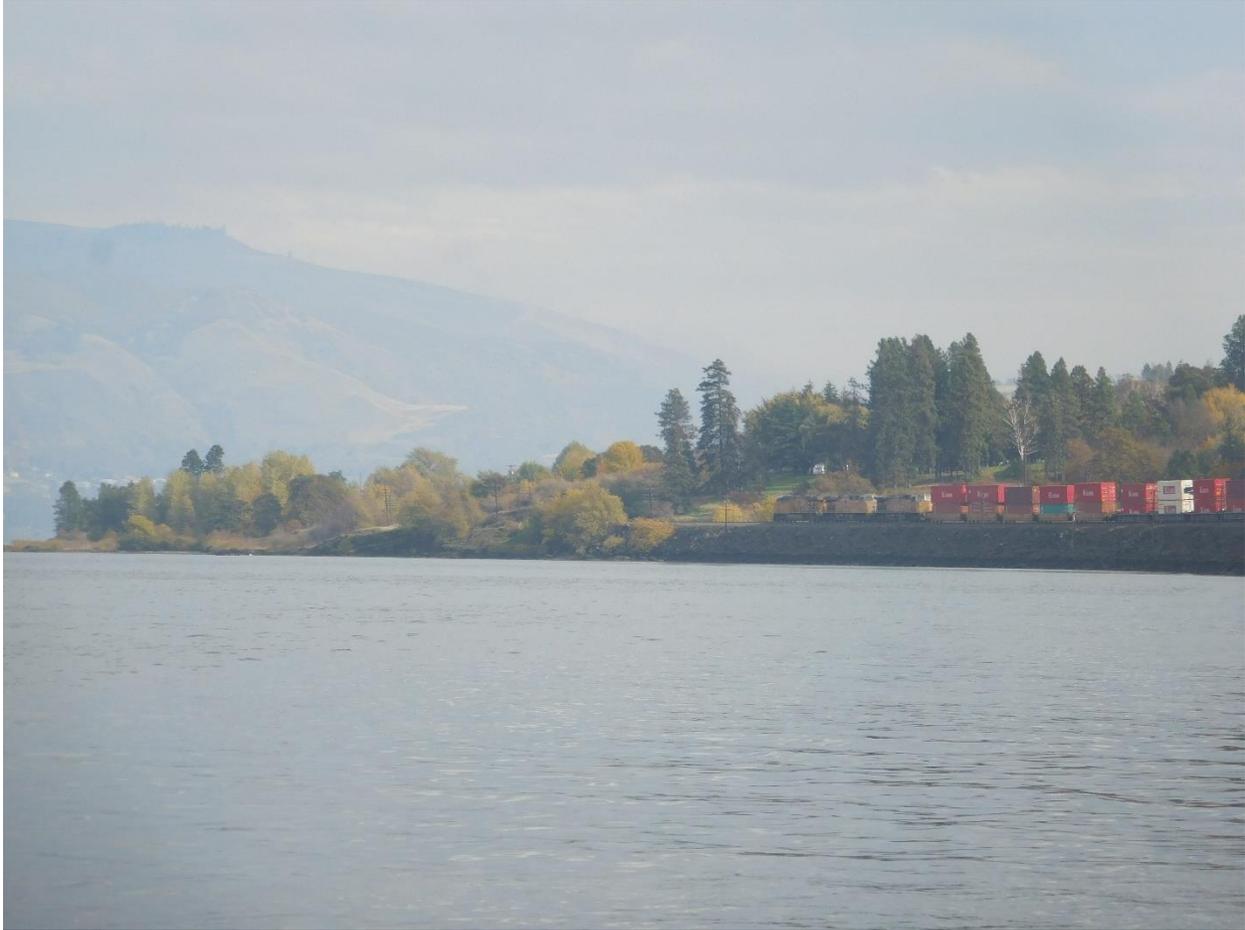
This is another photo of the adverse visual impacts the operation of the railroad has on the NSA. The area of deciduous trees on the left side of the photo is the area that the applicant proposed to clear and use as a staging area.

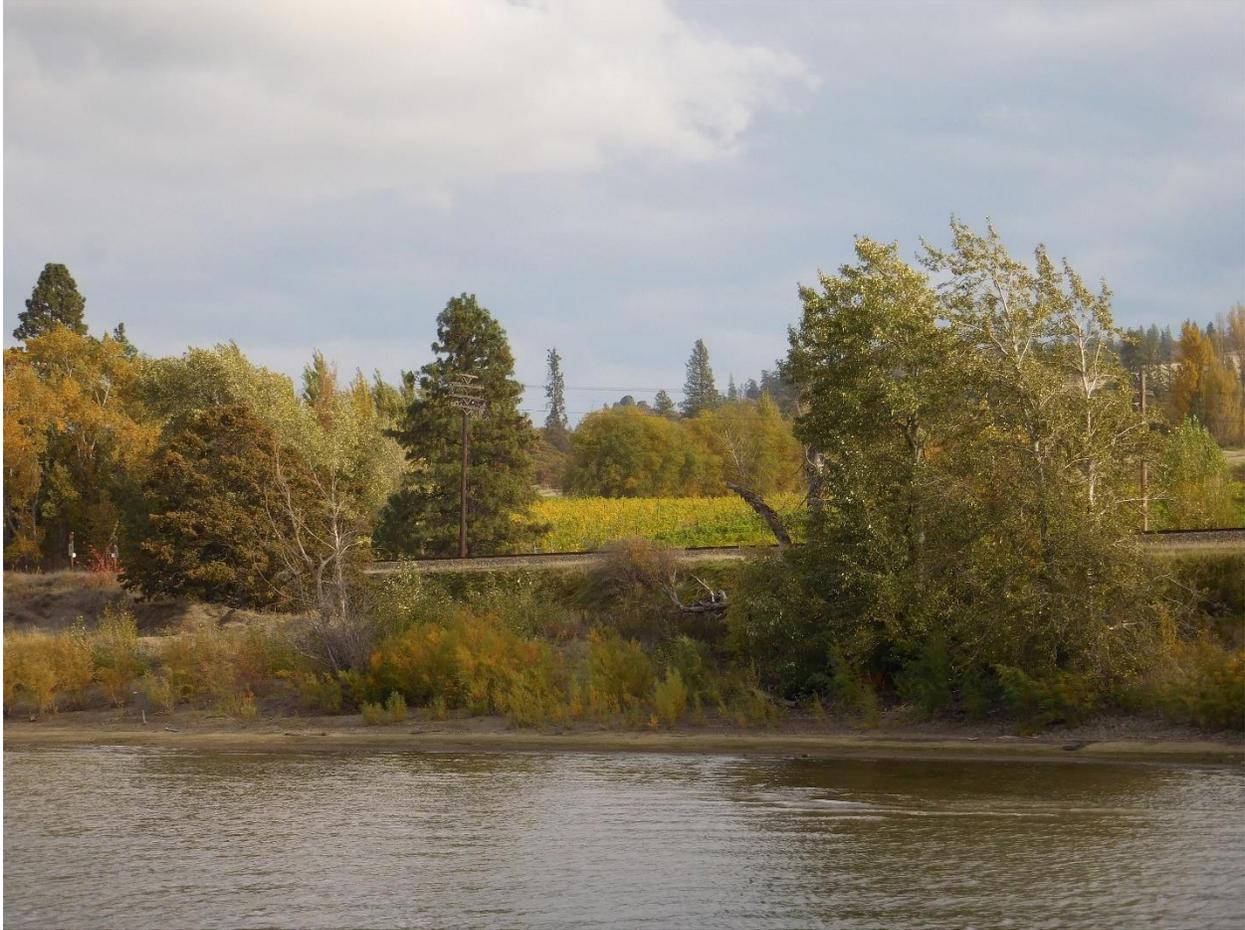
This is a photo from a kayak of the tracks through the project area at approximately milepost 71. Despite the applicant's narrative, the tracks within the project area are clearly visible from the Columbia River KVA and the additional development would also be highly visible and not meet the required scenic area standards.

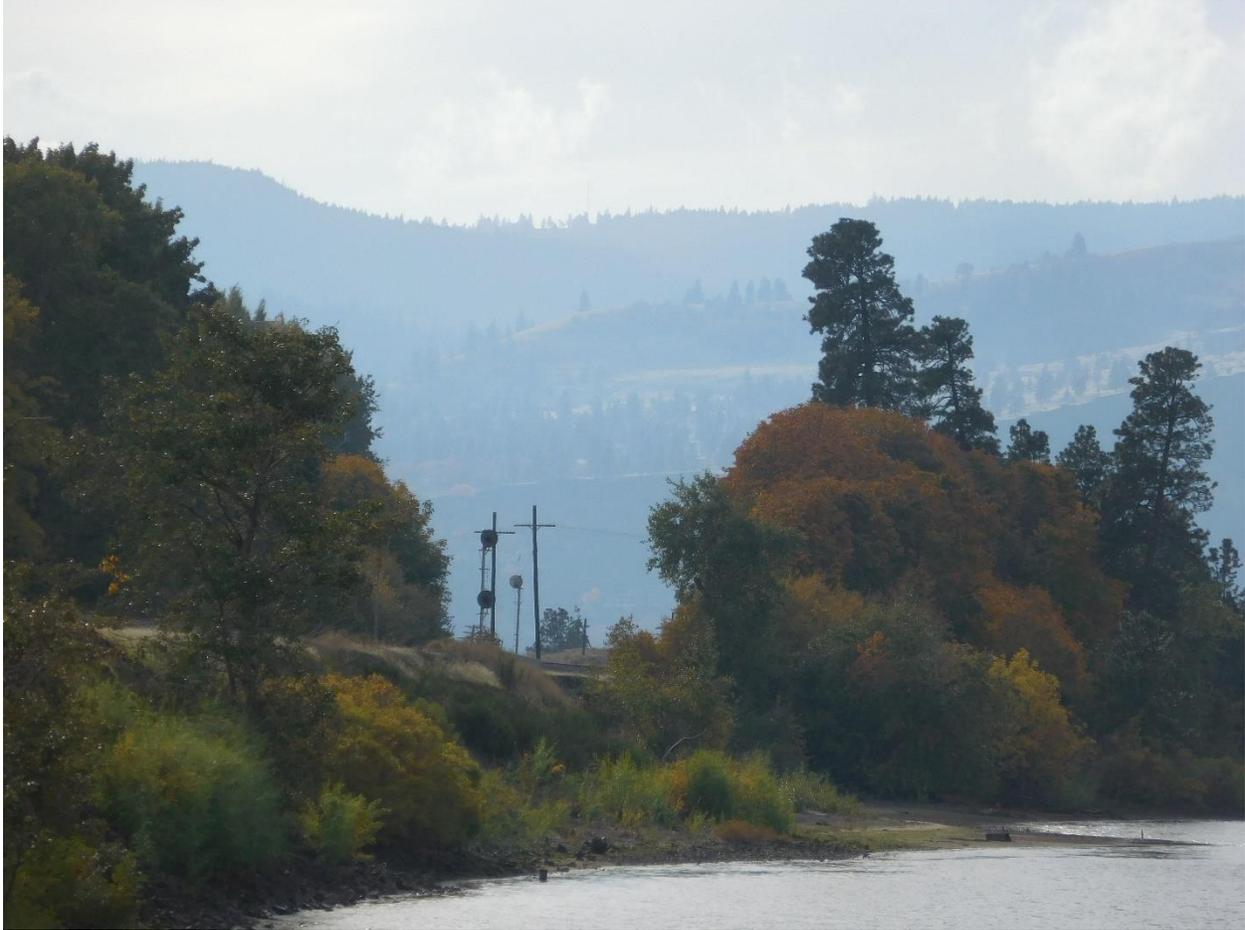
These signals and utility poles are clearly visible from the Columbia River KVA at approximately milepost 71. Despite the applicant's narrative, features like the rails and signals that would be located on the flat area on top of the bank would be highly visible from the Columbia River KVA and not meet the required scenic area standards.
